03/18/89 Evergreen International Airlines

Official Accident Report Index Page

Report Number	NTSB/AAR-90/02
Access Number	PB90-910402
Report Title	Evergreen International Airlines, McDonnell Douglas DC-9-33F, N931F, Saginaw, Texas, March 18, 1989
Report Date	April 23, 1990
Organization Name	National Transportation Safety Board Office of Aviation Safety Washington, D.C. 20594
WUN	5094A
Sponsor Name	NATIONAL TRANSPORTATION SAFETY BOARD Washington, D.C. 20594
Report Type	Aircraft Accident Report March 18, 1989
Distribution Status	This document is available to the public through the National Technical Information Service, Springfield, Virginia 22161
Report Class	UNCLASSIFIED
Pg Class	UNCLASSIFIED
Pages	85
Abstract	This report explains the crash of an Evergreen International Airlines McDonnell Douglas DC-09-33F, N931F, in Saginaw, Texas, on March 18, 1989. The safety issues discussed in the report include the cargo door closing procedures on DC-9 airplanes; the external cargo door markings on DC-9 airplanes; the door warning switch electrical wiring on DC-9 airplanes; and the actions of the carrier and the Federal Aviation Administration concerning these issues preceding the accident.

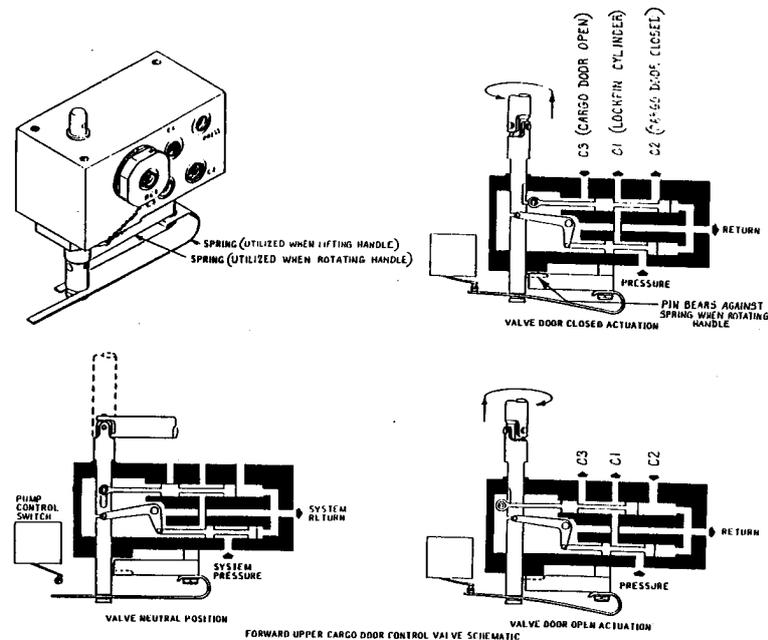
Figure 1.--Hydraulic routing within the cargo door hydraulic system.

1. The cargo door control valve - This valve was found in the "valve neutral" position (as opposed to the "door open" or the "door closed" position) within the wreckage. Damage to the valve did not allow testing in the "door open" or "door closed" positions. The valve was disassembled at its manufacturer's facility and no anomalies were found. [See Figure 1](#) for a cut-away diagram of this valve in its three operating positions.

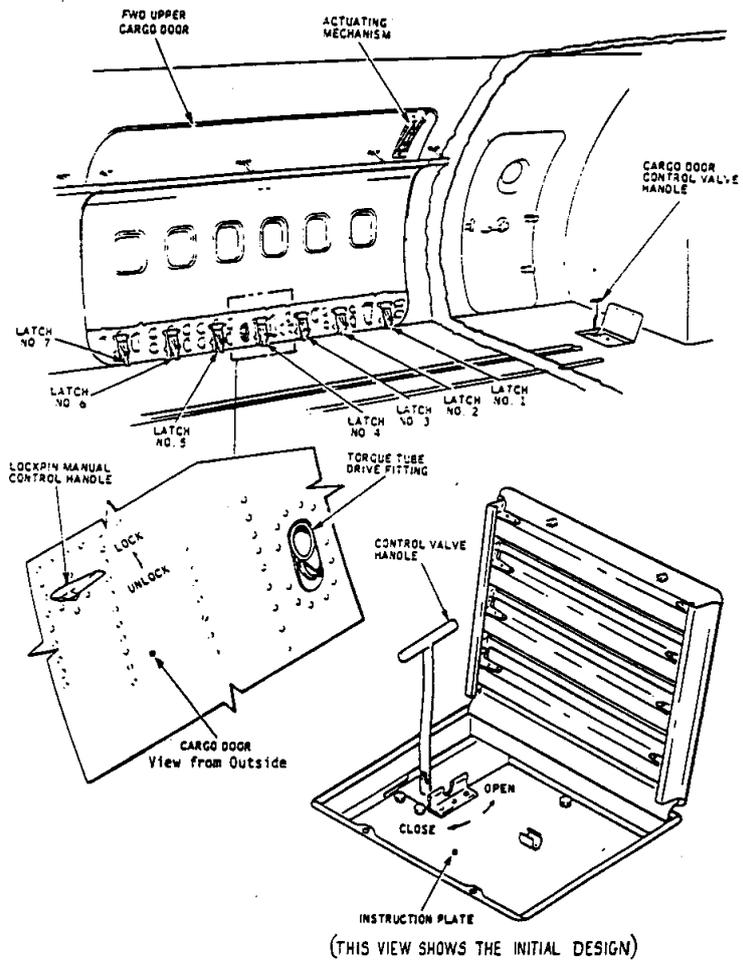
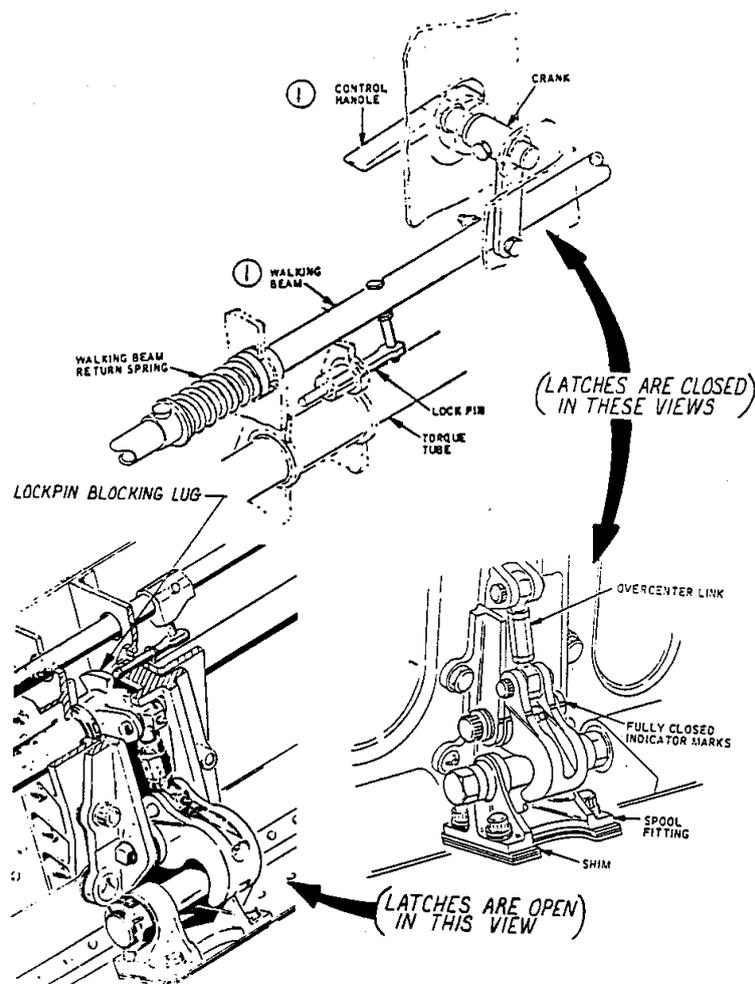
Figure 2.--Main cargo door components.

The open or closed status of the cargo door is also displayed by a cockpit warning light. The original 28 volt dc electrical circuit to illuminate the light consists of two switches wired in parallel. Both of the switches are spring loaded to the closed position. One is opened by mechanical actuation when the door lowers against the door jamb and the other is opened mechanically when the lockpin pushrod moves to a position where the lockpins are engaged in the latching hooks. Since the lockpins can engage only when the latching hooks are fully rotated over the door sill spools, an open switch indicates that the door is latched and locked. With either of the switches closed, the cockpit warning light is illuminated. When the door is properly closed, both switches open and the light is extinguished. The airplane manufacturer issued a service bulletin describing a modification to the cargo door warning circuit but the modification had not been accomplished on N931F as discussed in section 1.6.4. (See [figure 1](#) and [figure 2](#).)
